Subject: Parachute and Actuators Being Presently Tested at
El Centro

SUBJECT: PARACHUTE & SEAT TEST PROGRAM - EL CENTRO

1ST Static Ejection Seat Test

22, July, 1964

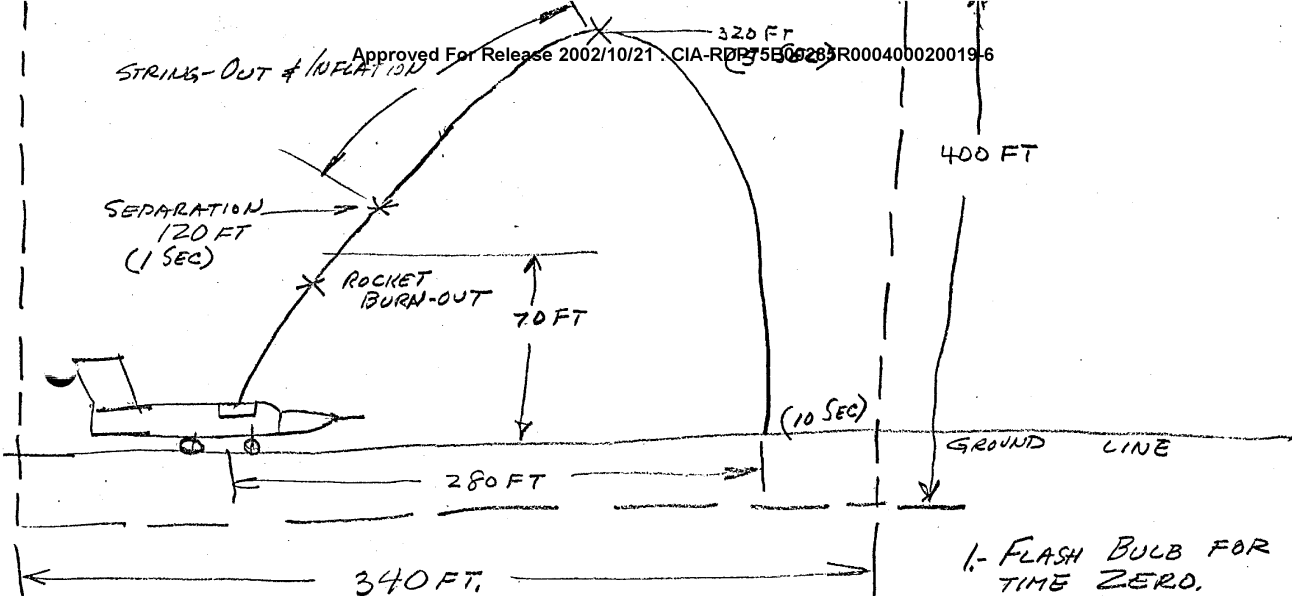
- ① TRAJECTORY CAMERA'S - (2) FIXED. 1.- FLASH BULB FOR TIME ZERO. 2.- No TRUCKS/VEHICLES IN VIEW.
 (340' X 400' HIGH) 200 FRAME/SEC? 20 F/S HULCHER?

- ② CLOSE UP CAMERA - FIXED

A.- HULCHER 20 FPS, FROM 0 TO BURN-OUT, (70 FT)
 (FOR ACCELERATION & THRUST)

- ③ CLOSE UP CAMERA'S - HAND PANNED

A.- LAUNCH - BURN-OUT - SEPARATION - STRING OUT -
 INFLATION, TOUCH DOWN,
 (FOR DETAIL, ON ROTATION - BELTS COMING LOOSE, ETC)

- ④ FOLLOW DUMMY & CHUTE - NOT SEAT

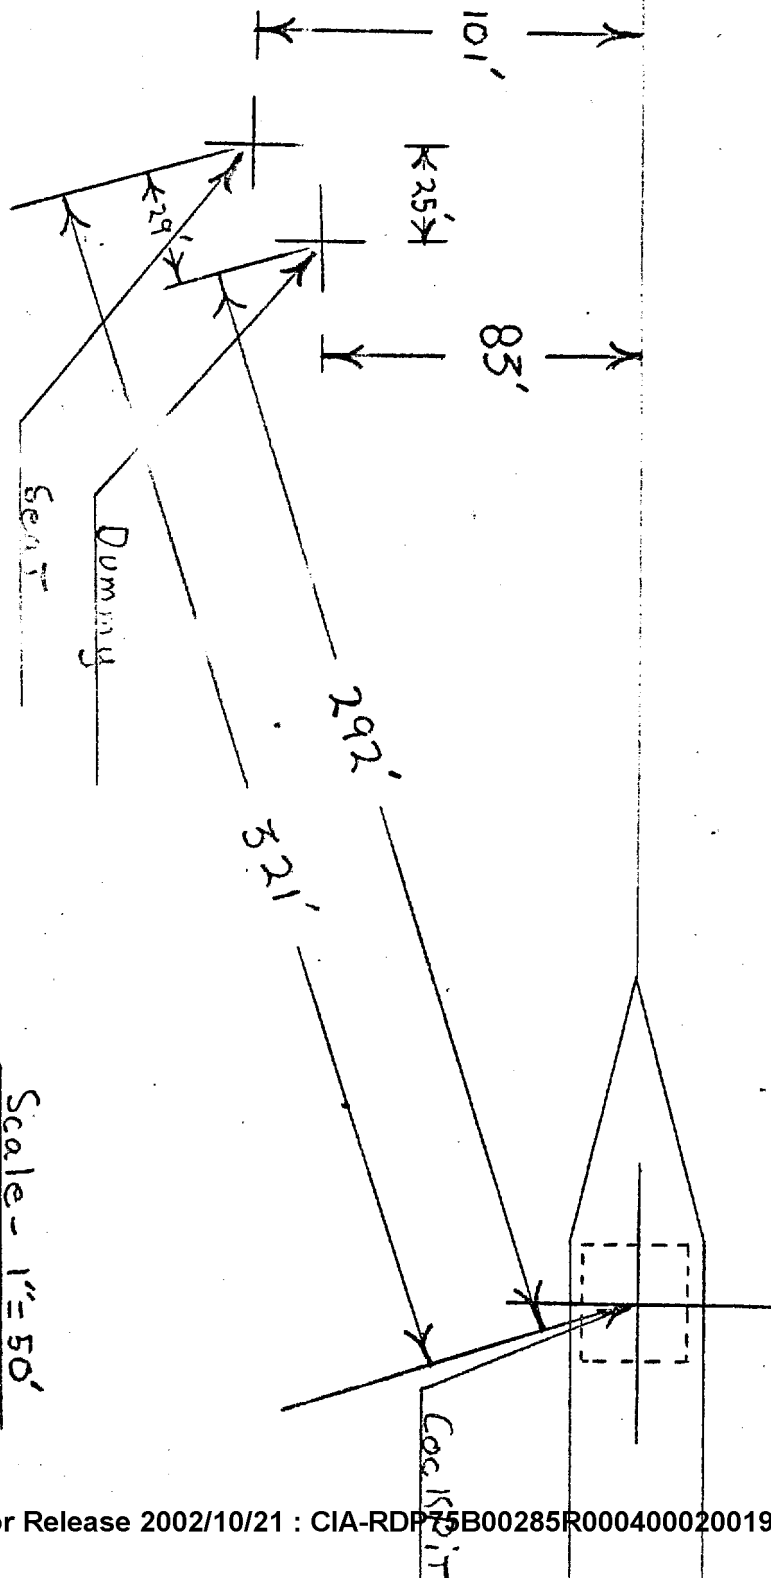
Scale - 1" = 50'

Estimated Dummy Height

(From Movies) = 300 (77)
